Excavation of Bath House (3)

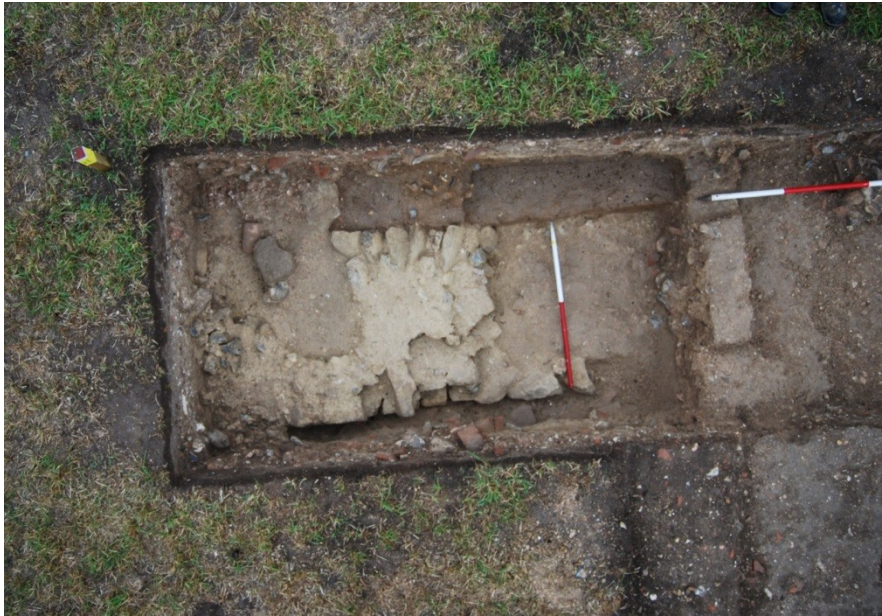
All the evidence from the 2016 excavation demonstrates that the Bath House was constructed to very high standards...

... as shown by stone faced, concrete filled walls a metre wide...

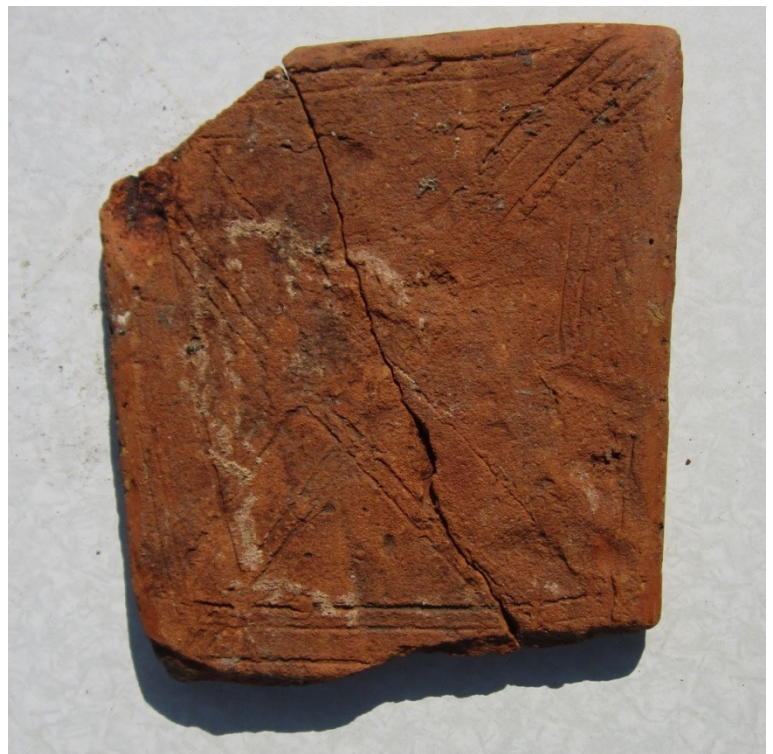
...and vaulted ceilings – using hollow wedge-shaped tiles to construct the vault.
